Limited Visual Dam Safety Inspection Summary Report

MA-088

HC&S Reservoir 84

May 2006

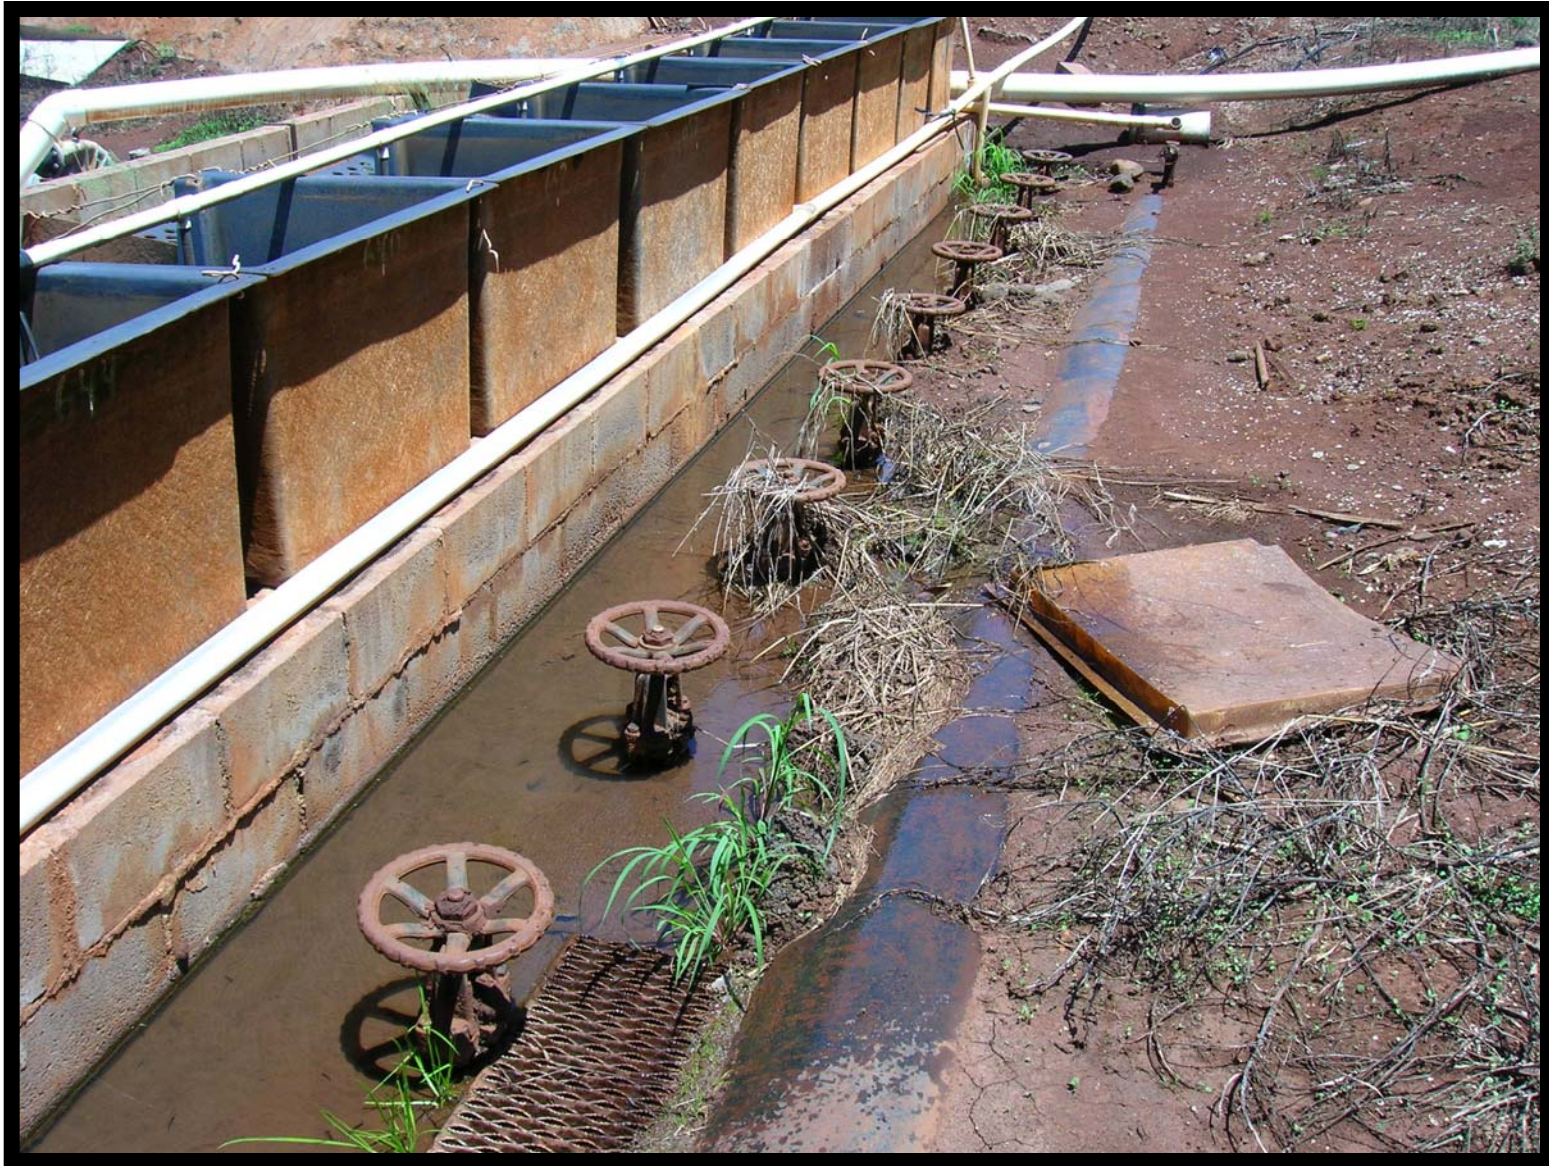
088 downstream slope

Tall grass, bushes and trees were observed on the downstream slope.

- c. Tree(s) were observed on the downstream slope. Trees have been identified as the probably cause of piping failures, and can possibly cause sever damage to the embankment if they are uprooted during a high winds. Corrective action is required to remove the tree hazards from the dam. Acceptable remedies include removal of the tree and its root structure down to a 2" diameter and reconstructing the damaged embankment section. All repair work shall be accomplished as per the requirements of licensed geotechnical or structural engineer. Routinely monitor the damaged area for signs of settlement and seepage.

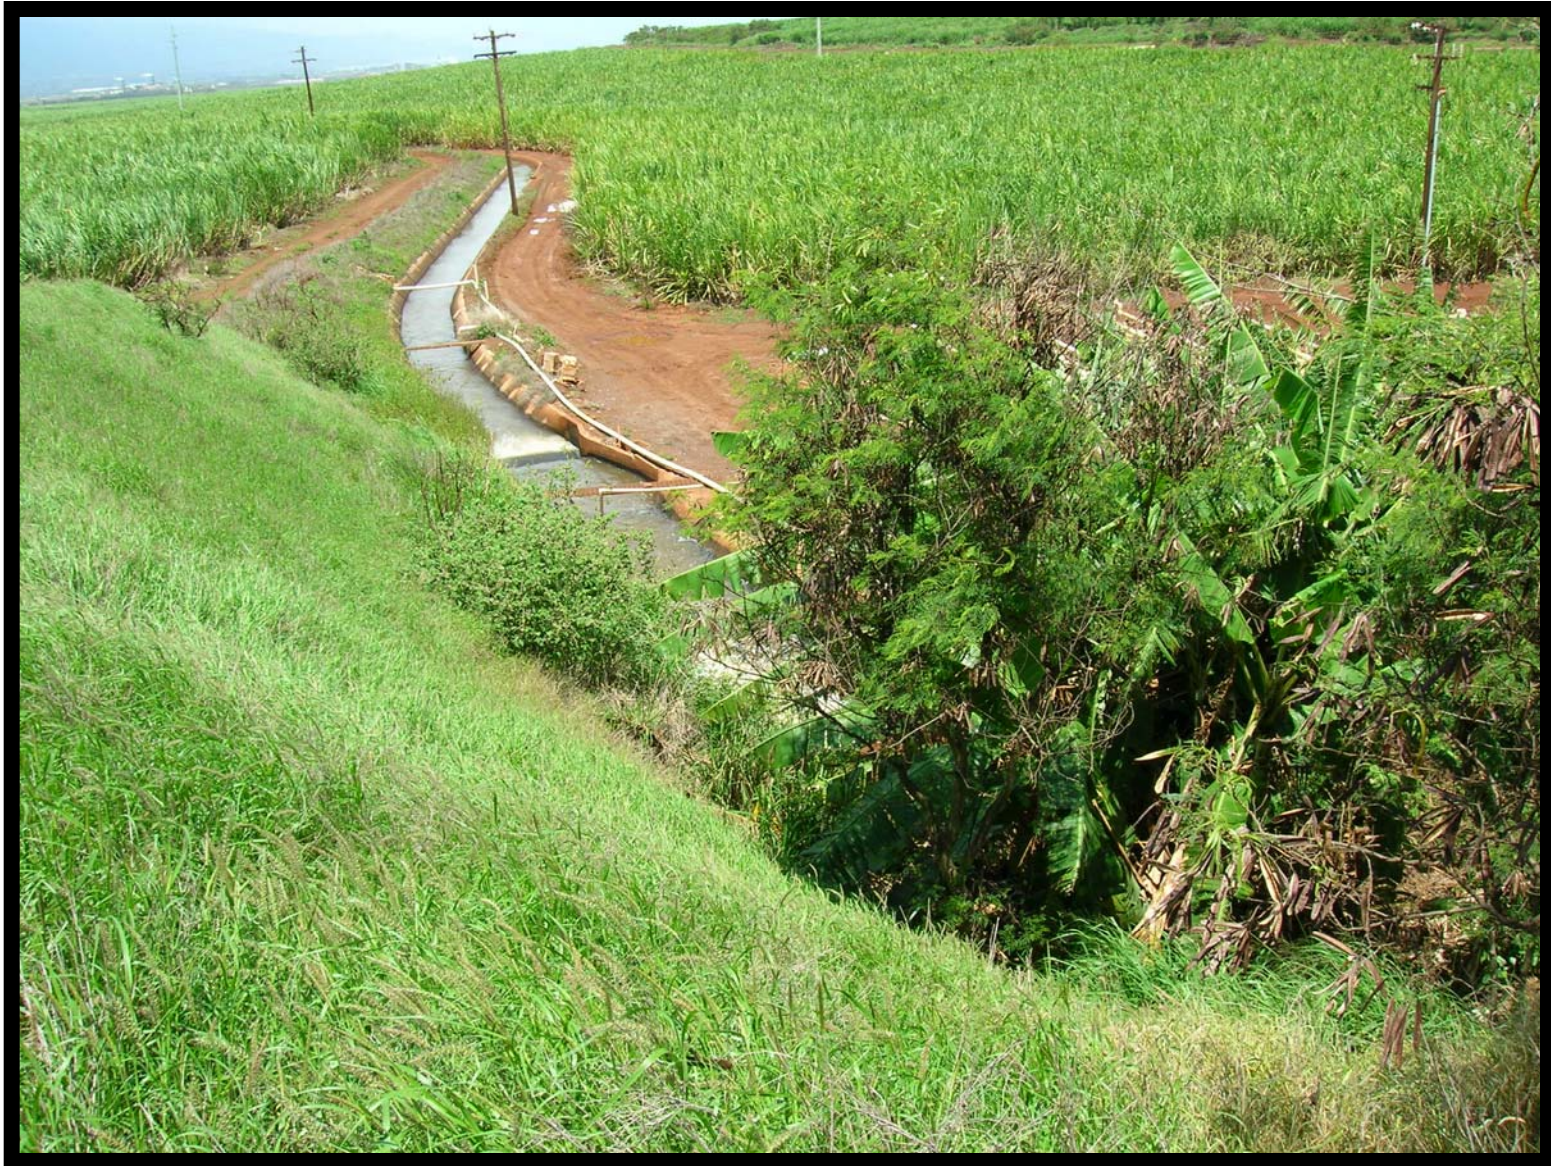
- a. The Spillway appeared to be in fair to poor condition and requires corrective action.
- b. Unclear if spillway is adequately sized. Spillway should pass the probable maximum flood. Verify spillway capacity and take corrective action as required.

088 inlet and spillway - 2nd Inlet (bottom) and spillway (top)

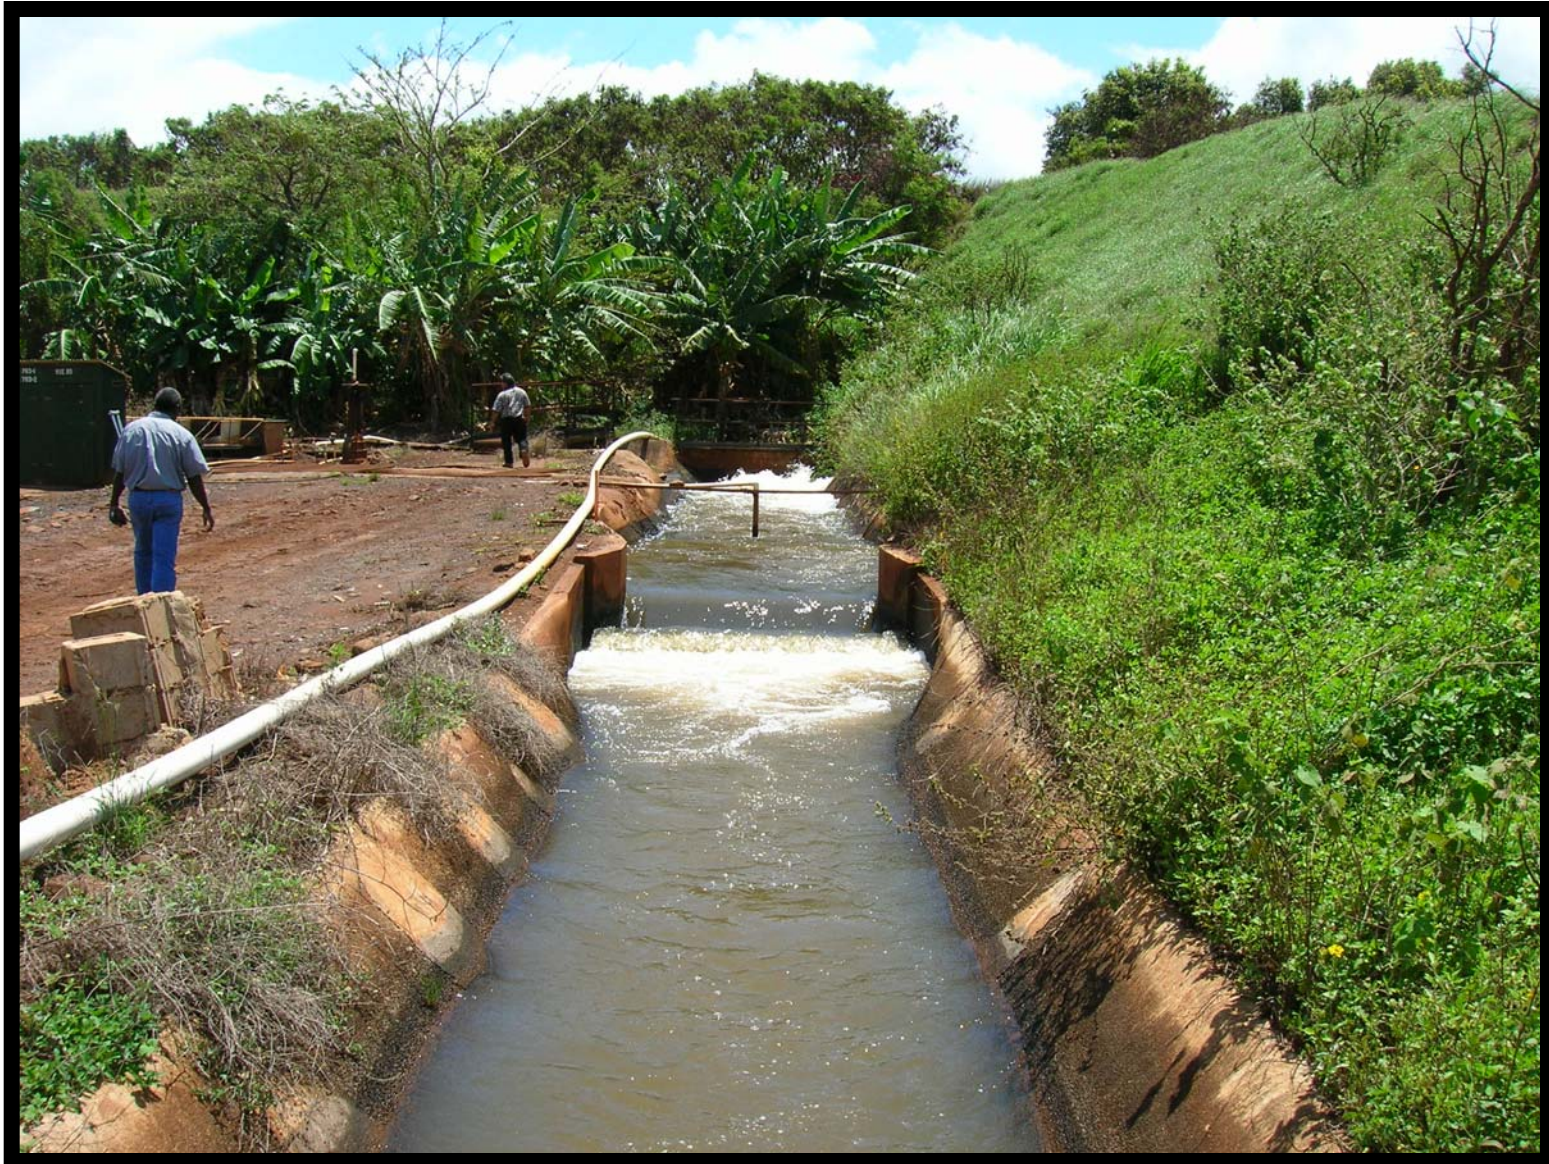
088 outlet channel

- a. The downstream channel was not inspected.
- b. The downstream channel appeared to be in fair to poor condition and requires corrective action.

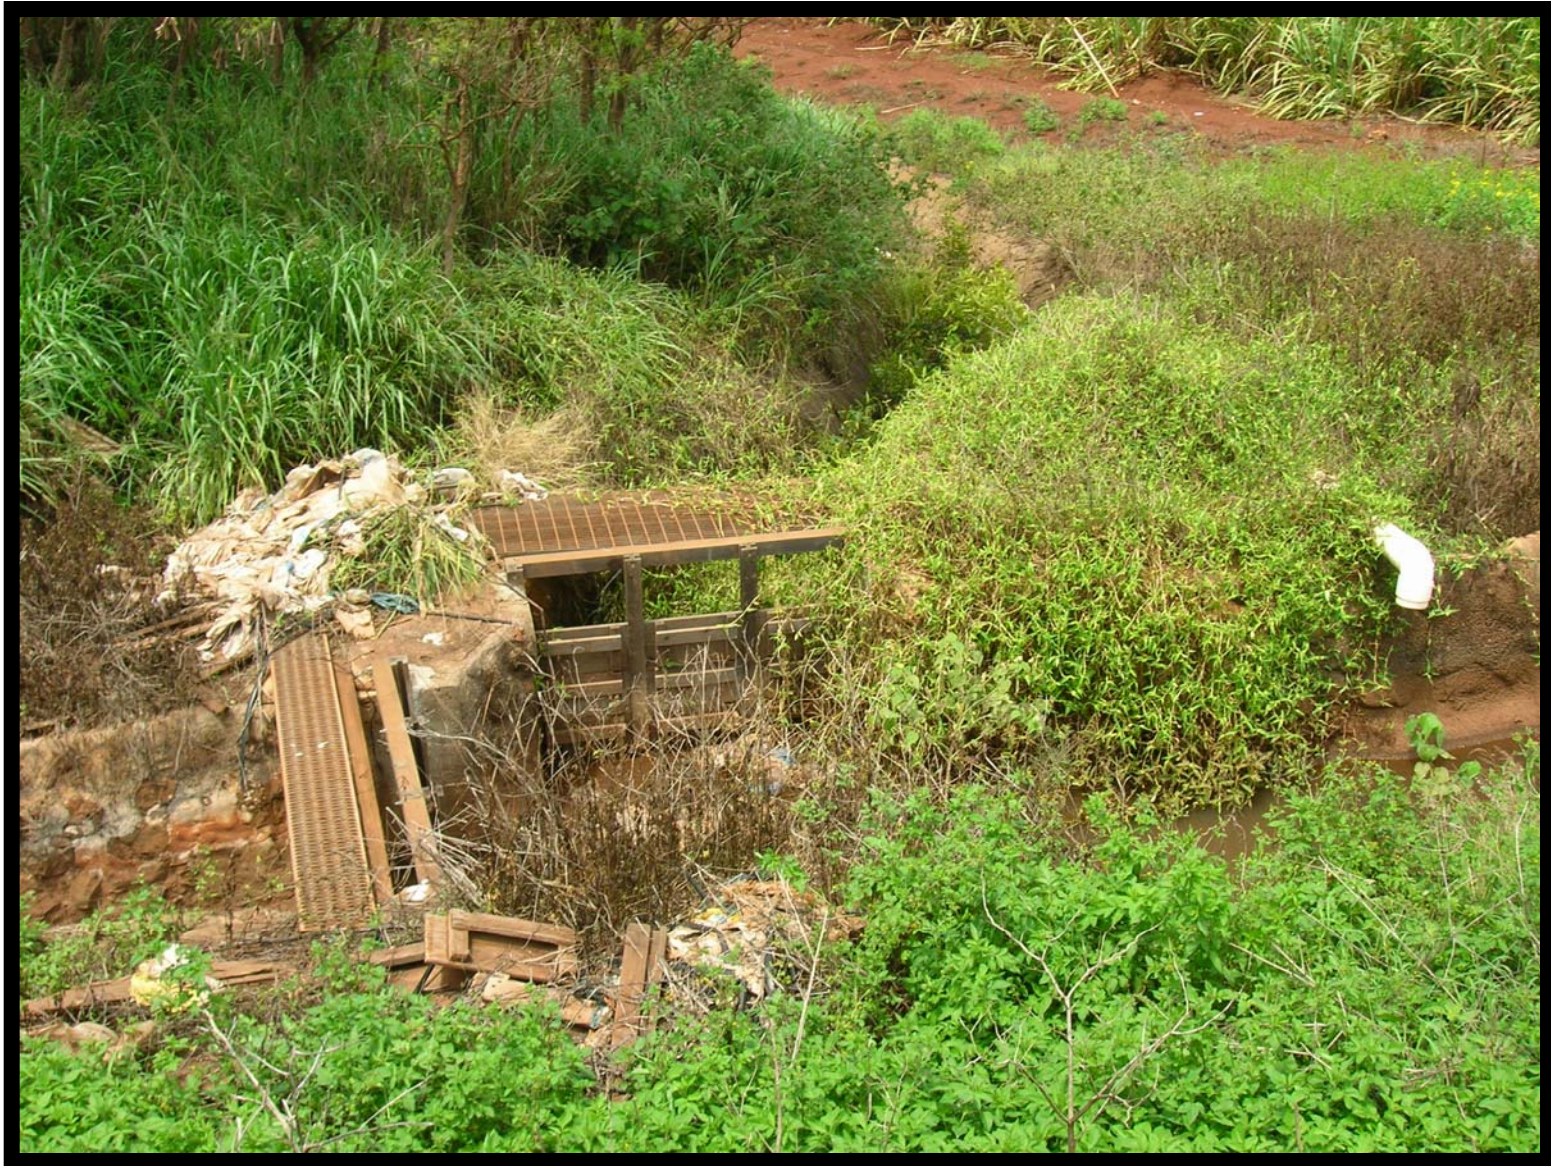
088 seep 3 - Small seep in downstream concrete ditch

- d. Rut and/or Gully erosion was observed on the slope, which requires maintenance and/or repair. Description: Fill gully with compacted fill
- e. Seepage/Ponding water was observed. Monitor and conduct further investigation to locate the source of water and extent of any possible hazardous or developing condition.
